Maps Are Only Guidelines: The Shocking Truth

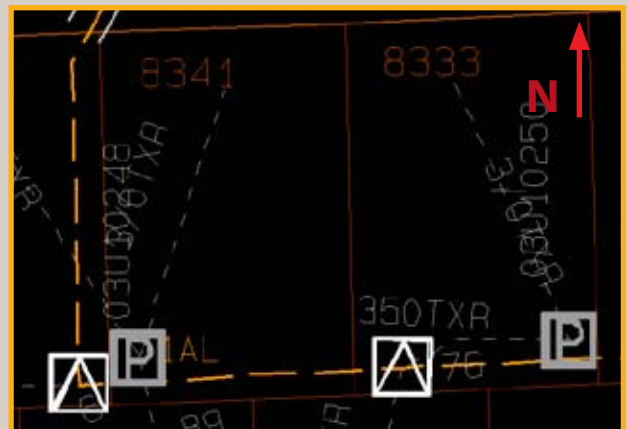
Original Map

A homeowner calls for marks to install a fence in the backyard at 8333 Oak Street. The locator checked the map as shown on the facing page (**Original Map**) and marks the service to the home, the secondary main from the pedestal back to the transformer and the primary line which runs across the rear of the property. As an experienced field technician, the locate could not have been more routine. The homeowner starts digging post holes being very mindful of the marks. As he is digging along the west lot line, well away from the marks, he senses something in the hole which also happens to be filled partially with water. He reaches into the hole and receives a painful electric shock. The utility first responder quickly determines that the service to 8341 (the home next door) has been severed. He also notes that it was not marked.

The locating contractor investigates and determines that they are not responsible because the service to 8341 took an “unusual and unpredictable” route from the transformer to the home rather than the pedestal as shown on the map (**Original Map**). Further investigation by the utility revealed that a proper sweep around the transformer would have detected a signal on the missed service. Mistake number one? Not really. Take a look at the photo below taken on a locate at 8341 Oak Street a little more than a year prior to the damage. Yes, that’s the service being marked running to the transformer on the property at 8333. Clearly, the map error should have been caught and corrected. Not only that—the same field technician marked both tickets. So much for that legendary memory I mentioned earlier because it appears that, at least this field technician, is mortal.

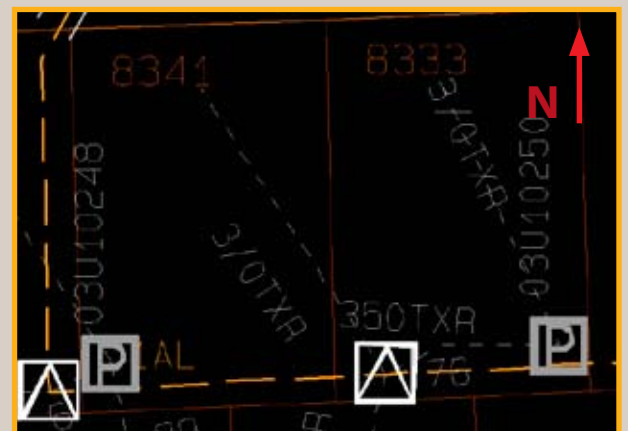
Corrected Map

literally dozens of opportunities to identify and correct the error (see **Corrected Map** on facing page).

1. Underground facility owners should place a high value for creating and maintaining accurate facility maps. Contract locating services should hold the facility owner accountable for providing current and accurate facility map records.

2. Construction crews must be trained to accurately report as-built data and about the consequences of failing to report variances from engineering drawings.

3. Together, facility owners and field locating technicians must eradicate the erroneous notion that maps are only “guidelines.” Facility maps are repositories of information vital to the field locating and marking process. In essence, map data is no different from the electronic feedback being given by the receiver. When a proper signal is detected (verifying expected facility depth) and this data coincides with the map records along with visual verification of the worksite, the field technician can feel confident that the target buried facility has indeed been detected and marked. If any of these pieces of information are not congruent, additional steps must be taken to assure that the target facility has been identified. Yes, these additional steps may reveal errors in the map records, but they also may reveal deficiencies in the locating equipment and/or the skills of the operator as well. **UF**

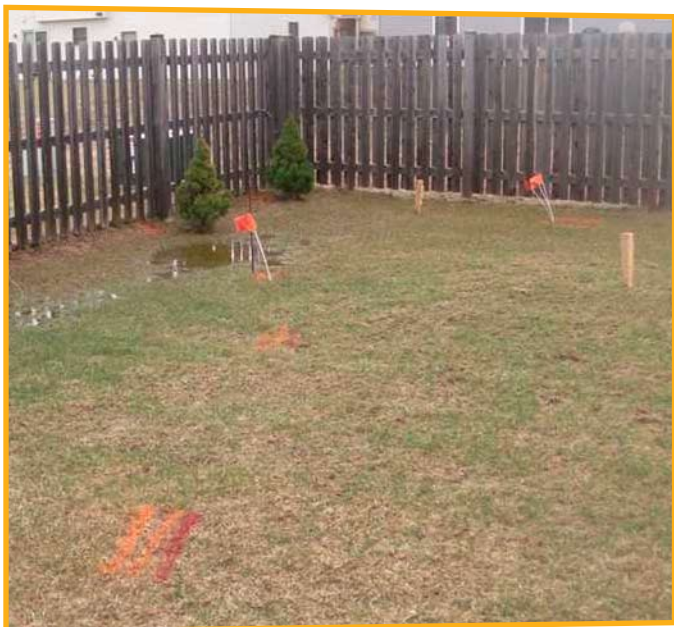
Looking Southeast from backyard of 8341 Oak Street.
